**Legionella Risk Assessment & Action Report****Identification, Assessment of Risk & Precaution To Be Taken With Respect To Legionella Bacteria**

**Hot & Cold-Water Systems**

Risk Assessment Survey Date: 18/05/2021

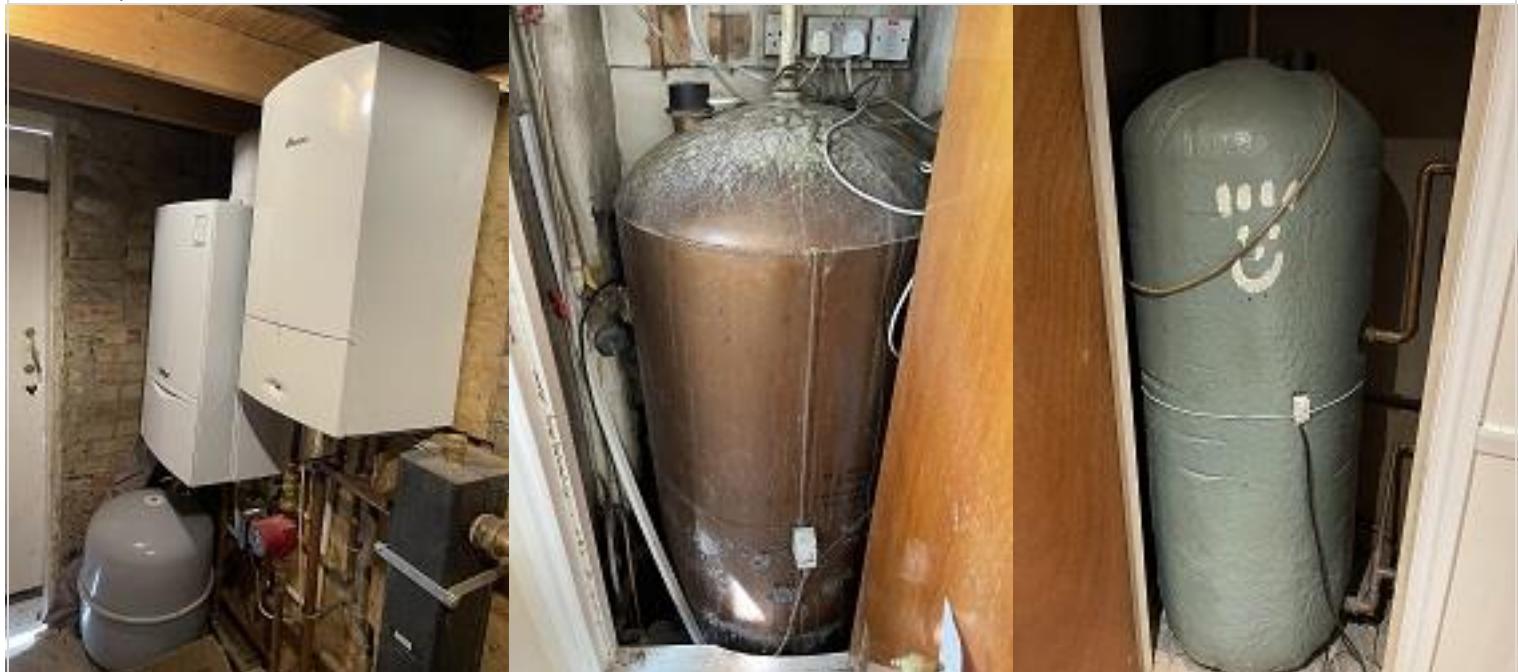
Asset Prefix	HWSDS
Assets ID	2
Number(s) of Boiler	1
Boiler Location	Rear plant room
Safe Access Available	Yes
Boiler Make & Model – 1	Greenstar 40CDi Conventional
Boiler Service Records Available	Unable to confirm
Hot Water Suppling to	Building 79
Hot Water Storage Tank Present	Yes
Number(s) of Hot Water Storage Tank	1
Storage Hot Water – Location	Top floor airing cupboard
Hot Water Storage Make & Mode – 1	Indirect Cylinder
Hot Water Storage Capacity	>300L
Electric Immersion Heaters	Yes
Storage Hot Water – 1 - Temperature ° C	57.0° C
Storage Service Records Available	Unable to confirm
Unit status at the time of inspection	In Service
Hot water supply Insulated	No
Deadlegs and Redundant Pipework	No
Hot Water Temperature ° C – Ground Floor	56.3° C
Hot Water Temperature ° C – First Floor	52.6° C
Hot Water Temperature ° C – Second Floor	52.5° C
Hot Water Temperature ° C – Third Floor	56.5° C
Is Expansion Vessel present?	No

### **Comments**

Currently the hot water temperatures are satisfactory and very limited access to building.

The design and installation of hot water services are satisfactory.

Apartments which are unoccupied causing dead legs in water distribution system.

### **Recommendation**

Temperature setting on the boiler & calorifier must be heated & stored hot water above 50 & below 60 Degree C to avoid legionella bacterial to get multiple.

Monthly temperature checks should be carried out by competent person and records must be maintained.

Regular servicing and maintenance of the boilers and calorifiers are essential to maintain the optimum operating efficiency, safety and accurate hot water temperature supply to avoid legionella bacteria to get multiple.

Currently temporary dead ends on hot water distribution system to those bedrooms which are vacant, during periods of unoccupancy all outlets on hot water systems should be flushed through at least once a week for at least 2 minutes. For longer periods considered draining the system. Make sure system is flushed through when it is re-occupied by running all outlets for at least two minutes. Aerosol production should be minimised during this process.

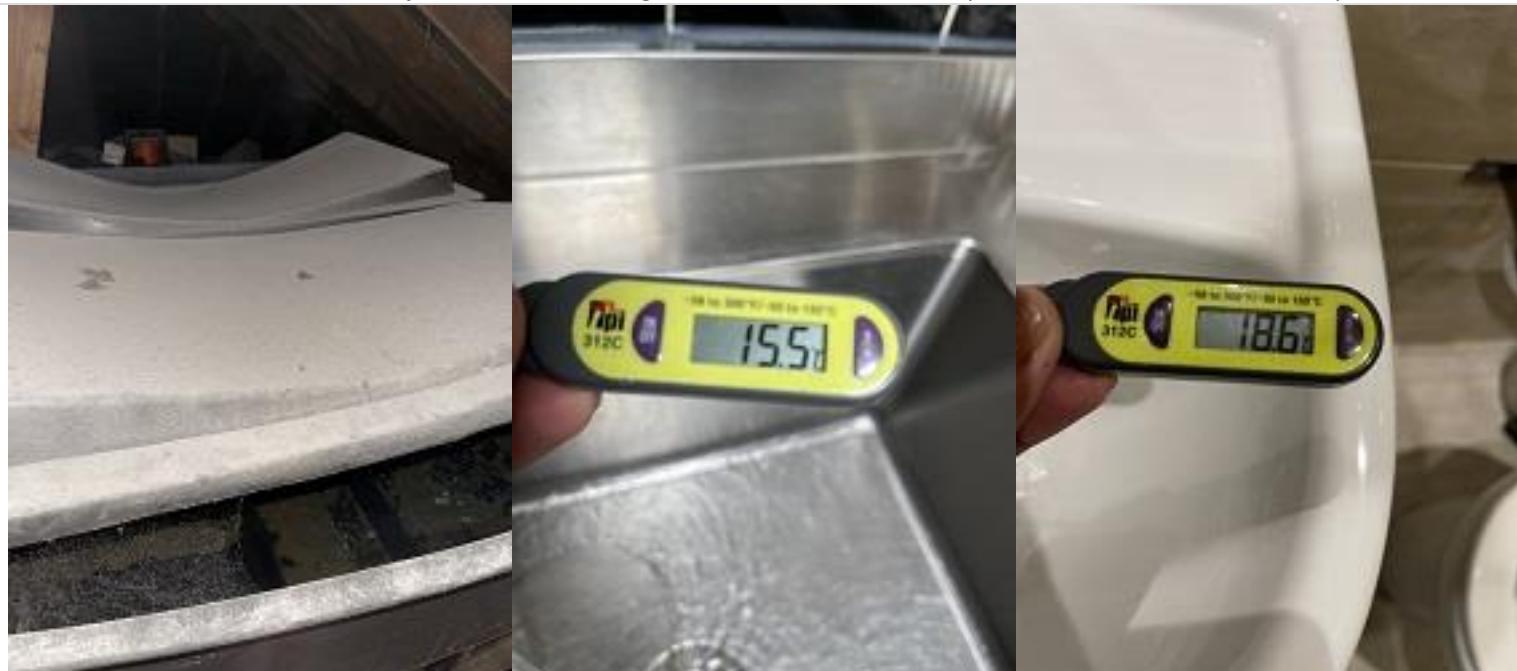
Asset Prefix	CWSDS
Assets ID	2
Cold Water Storage Tank Present	Yes
Number(s) of Storage Tank	2
Location of Storage Tank	Loft
Safe Access Available	Yes
Cold water supply Insulated	No
Dead legs and Redundant Pipework	No
Cold Water Temperature ° C – Basement	18.5° C
Cold Water Temperature ° C – Ground Floor	18.6° C
Cold Water Temperature ° C – First Floor	19.3° C
Cold Water Temperature ° C – Second Floor	15.6° C
Cold Water Temperature ° C – Third Floor	16.9° C
Cold Water Temperature ° C – Tank	16.5° C
Safe Access Available	Yes
Adequate Headroom	No
Illuminated	No
Material of Tank	Plastic
Tank Insulation	No
Tank Capacity	>100L
Adequate Lid	Yes
Warning Pipe Fitted	Yes
Supply Insulated	No
External Condition	Debris

Internal Condition	Cleaned
Sediment/Scale/Slime/ Corrosion	No
Storage Tank Inlet / Outlet on Same Side	No
Parallel Tank(s)	Yes
Is there a turnover of stored cold water within 24 hours	Yes
Adequate Record Keeping	No
Disinfection Program	No
Scale Present on the Outlet	No
Overall Risk Rating	Tolerable or Unlikely (Low)

### Recommendation

- Water must flow from cold outlets at below 20 Degree C to minimise legionella risk within 2 minutes.
- Currently the cold-water temperatures are satisfactory.
- Any little used outlets in bedrooms should be flushed through weekly by running water through the outlets for at least two minutes.
- Storage tank receives a high turnover during full occupancy and it is therefore assumed that the water hygiene will be maintained to high standard.
- The legionella risk should be controlled by keeping the water distribution system clean and free from nutrients, including those arising from corrosion and lime scaled.
- Monthly temperature checks should be carried out by competent person and records must be maintained.
- Clean & sanitise outlets quarterly to reduce lime scale risk.

- Install thermal insulation jacket, it should be good in condition so that it protects from extremes of temperature.
